# Situation Photo Log

Wednesday, October 24, 2012

Kalamazoo River / Enbridge Spill

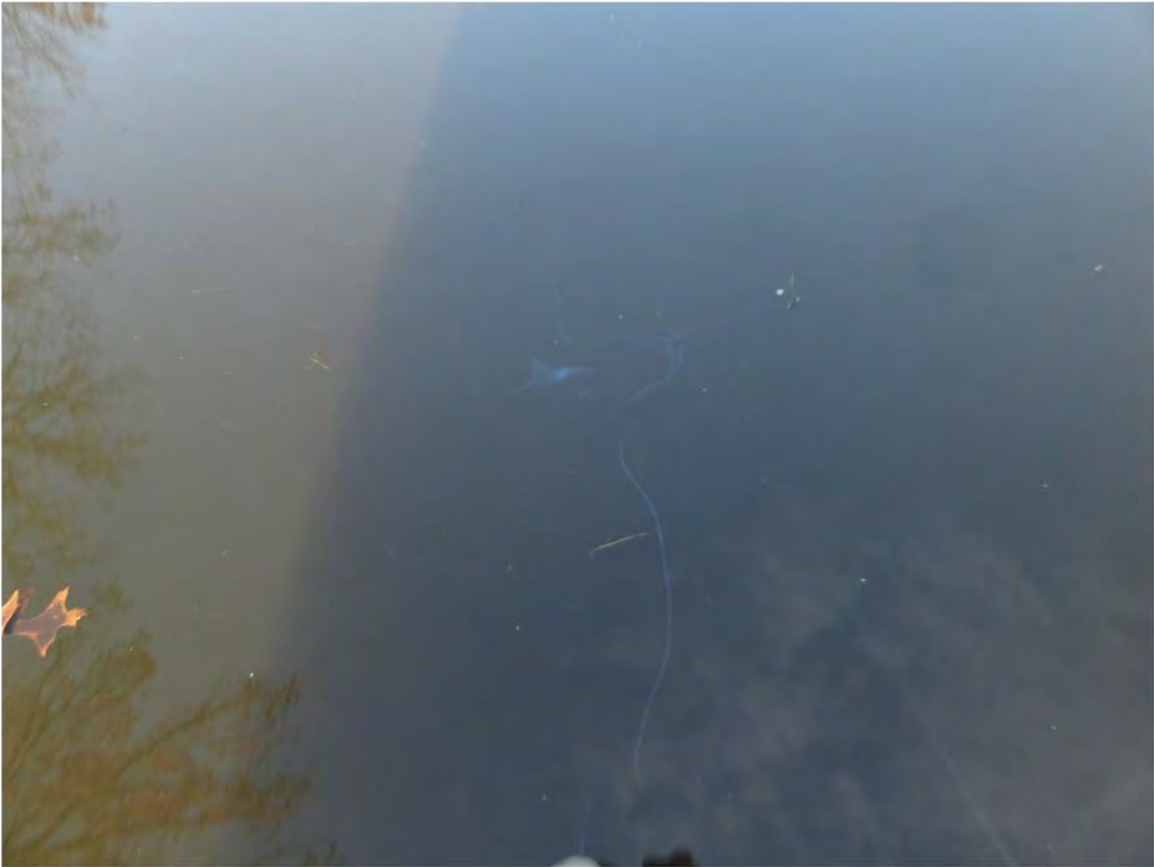
1. MP5.25 LDB area where sheen and tar globs were observed.

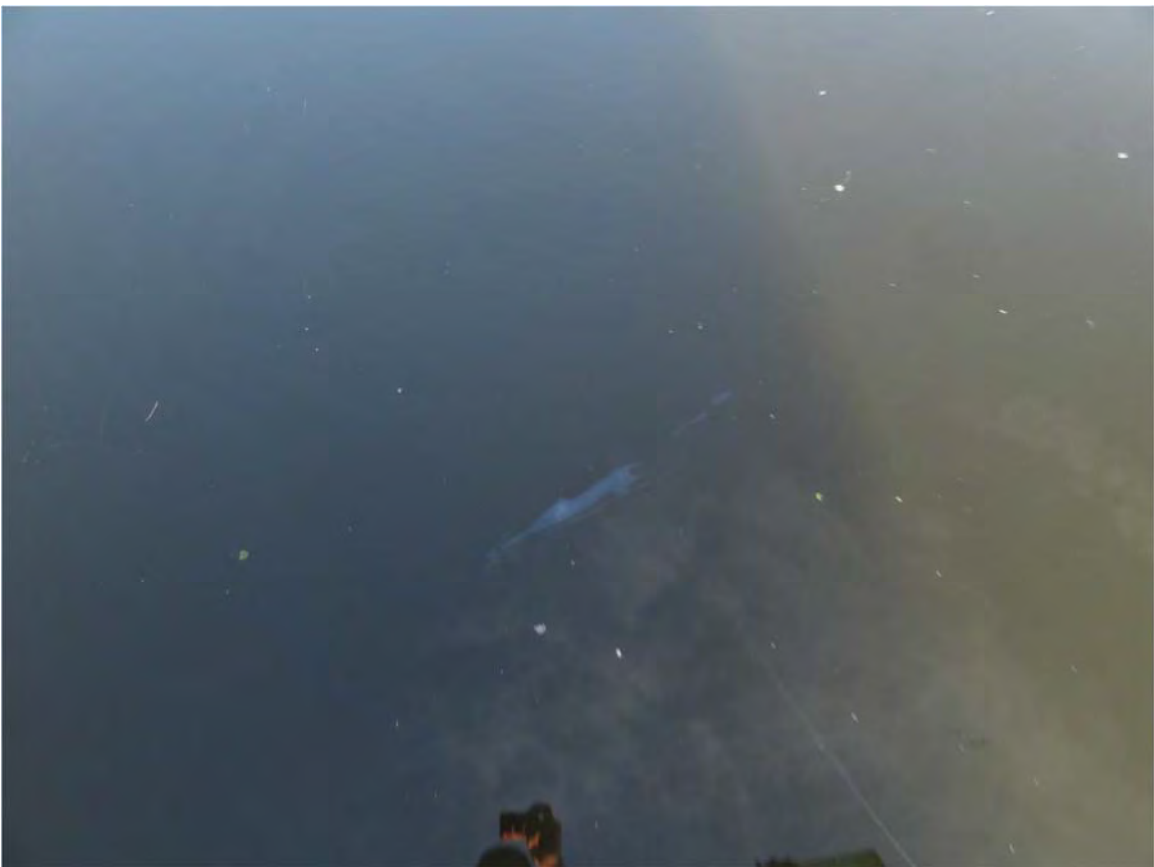
2. MP5.35 LDB sheen and tar globs observed.

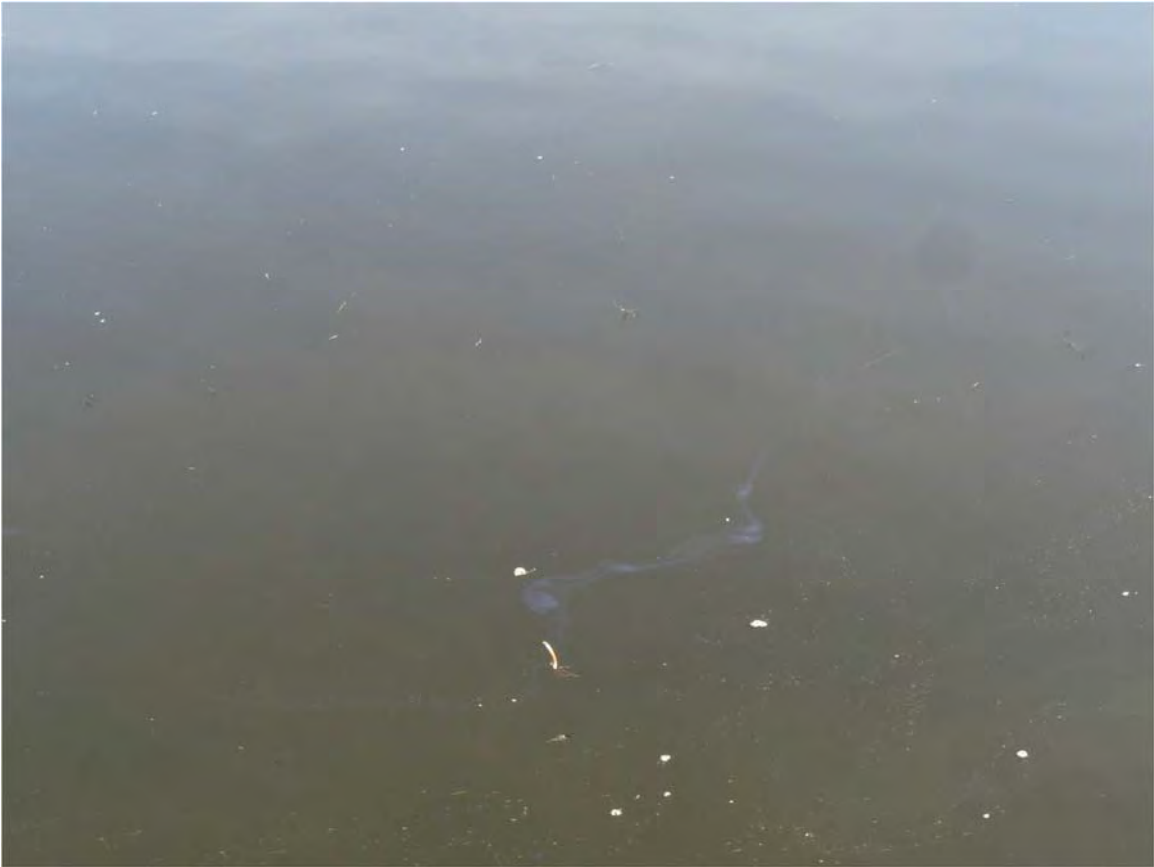
3. MP5.45 LDB sheen and tar globs observed.

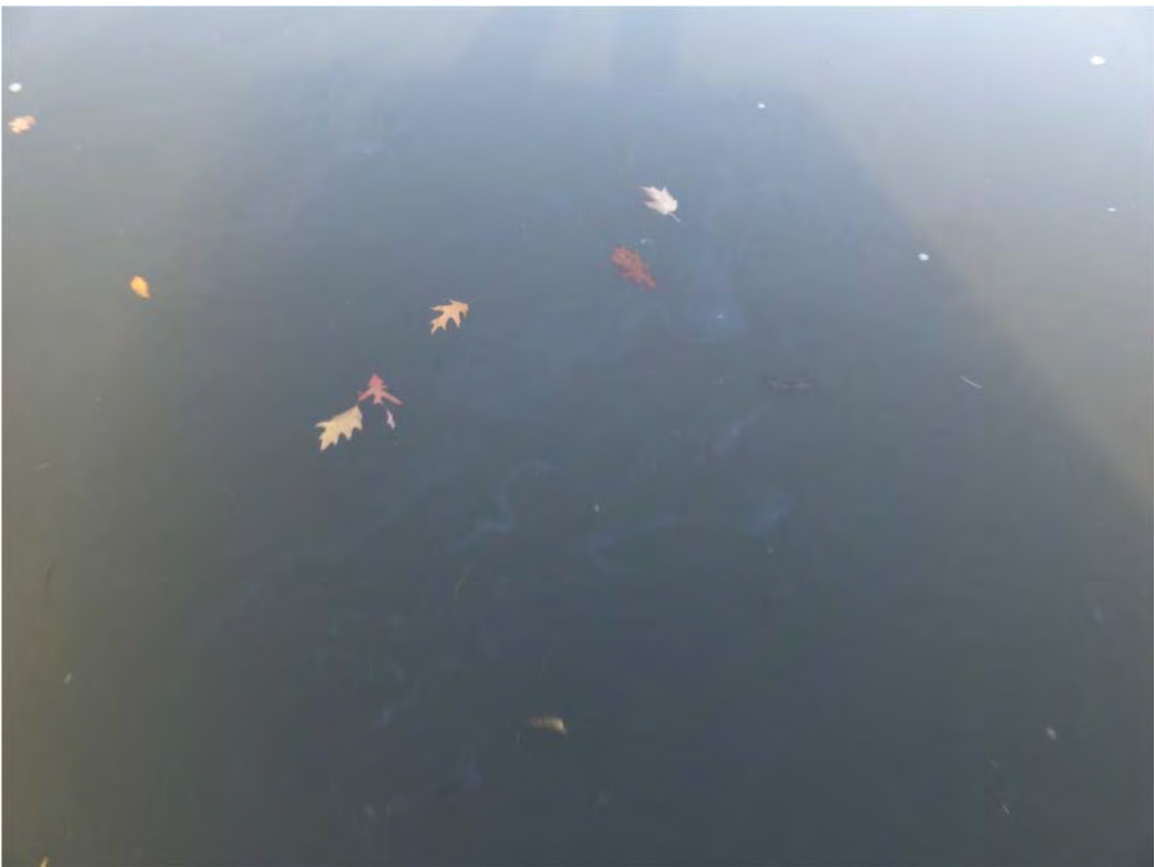
4. MP5.63 LDB sheen and tar globs observed.

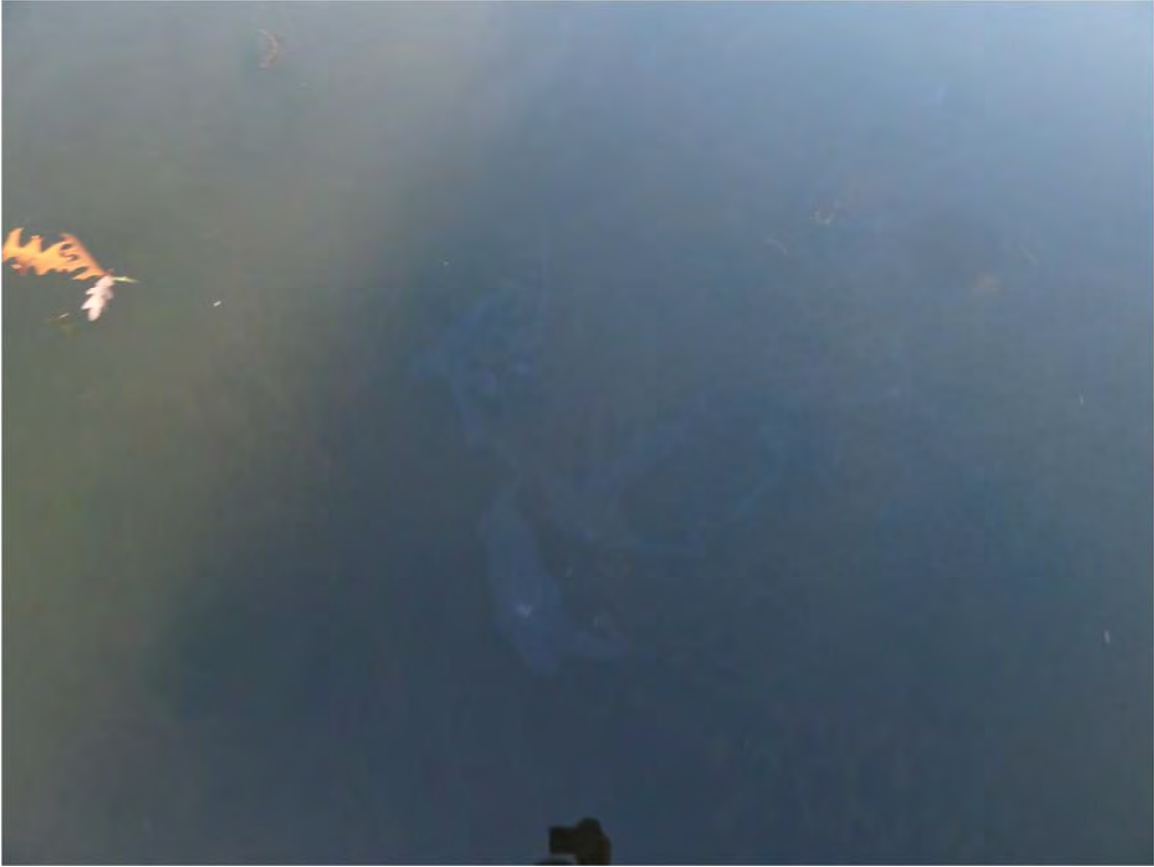
5. MP5.63 LDB sheen and tar globs observed.

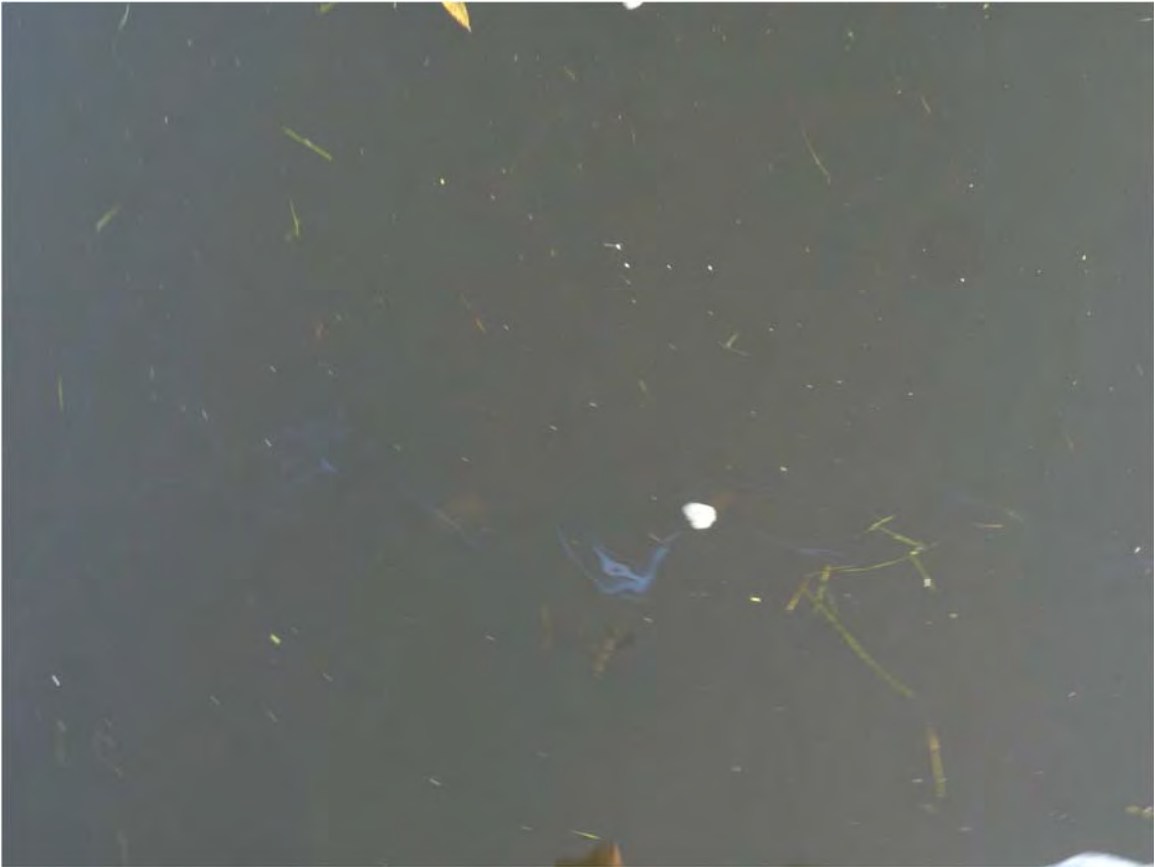
**7. Ceresco Dam Control Point Boom observed sheen and tar globs collecting along the boom.**

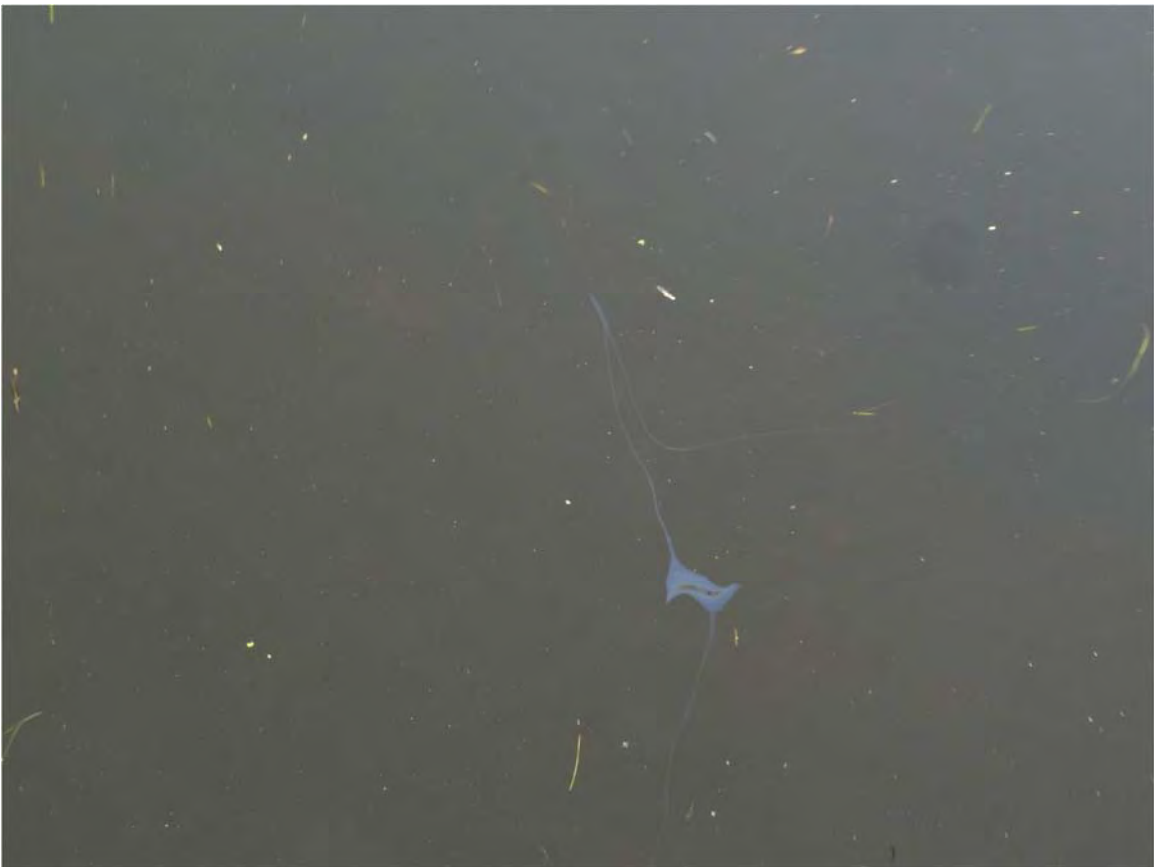
**8. MP5.63 RDB sheen and tar globs observed.**

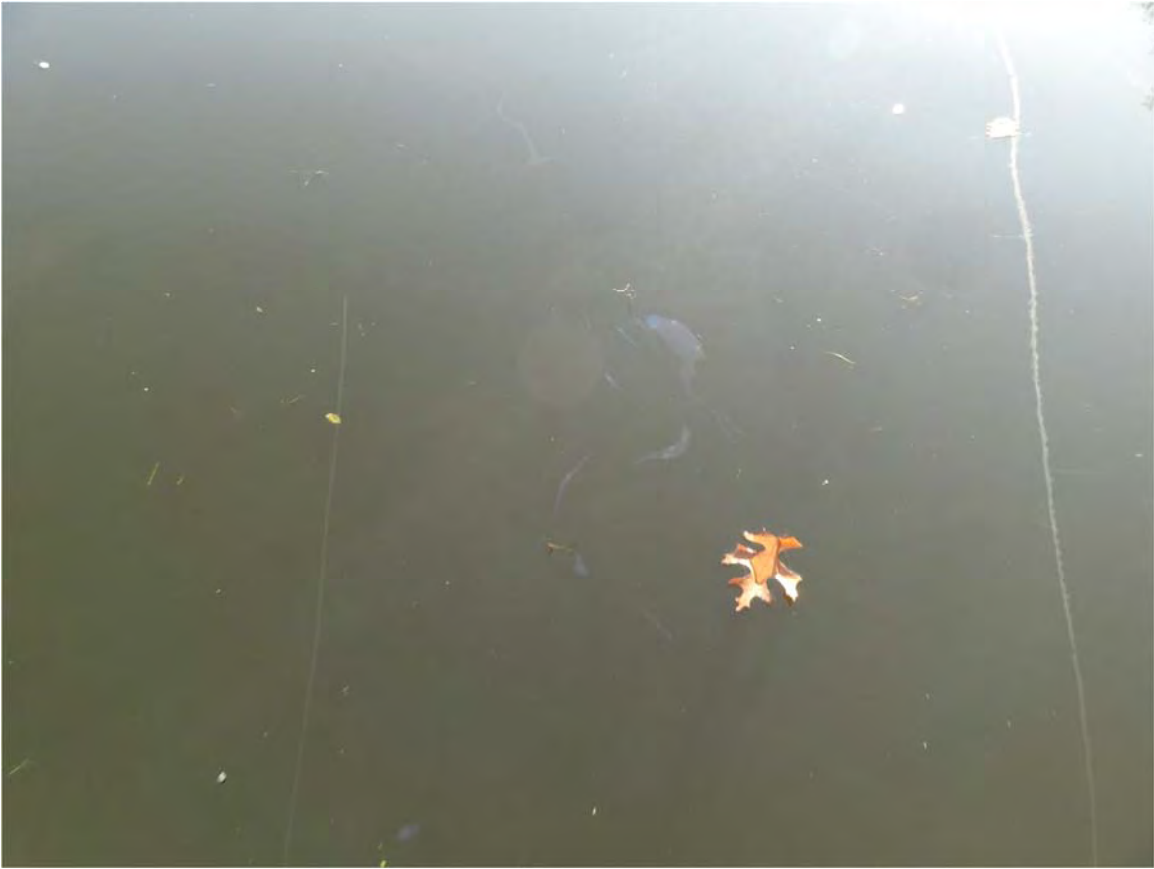
9. MP5.55 RDB sheen observed.

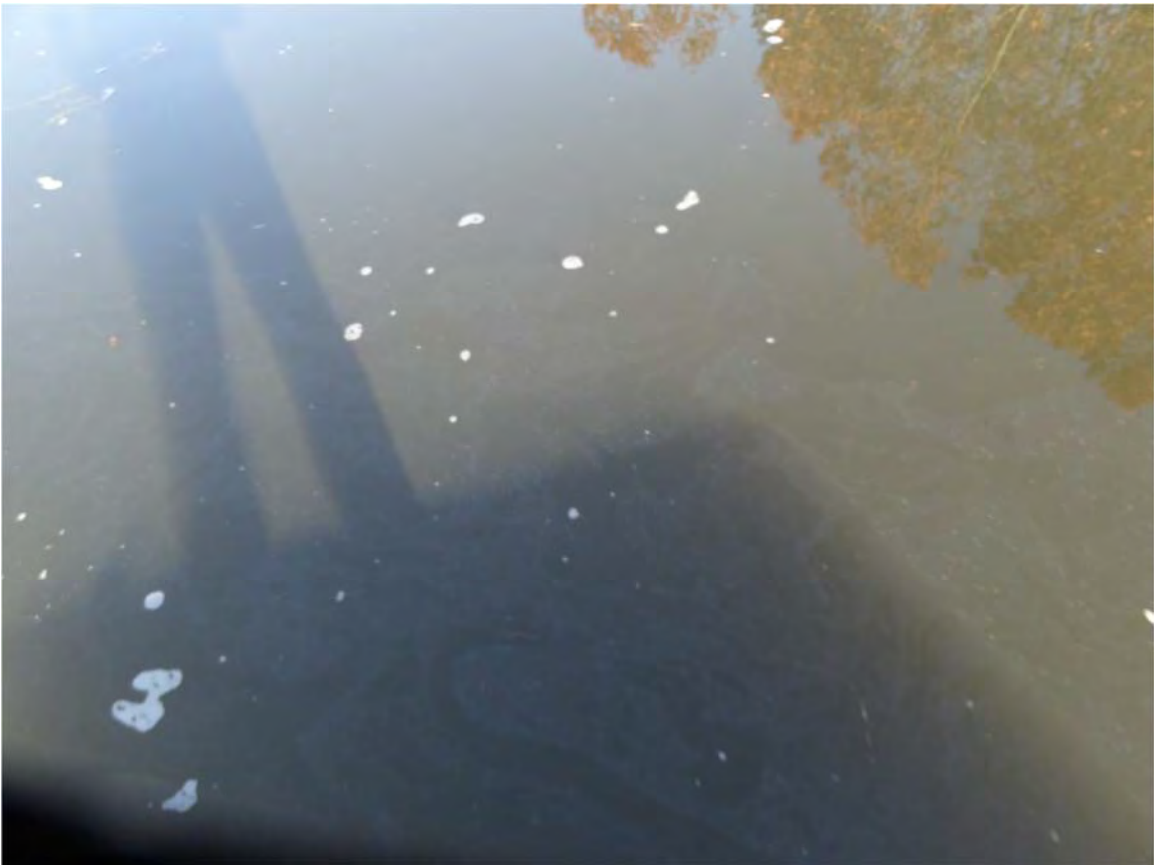
10. MP5.15 RDB sheen observed.

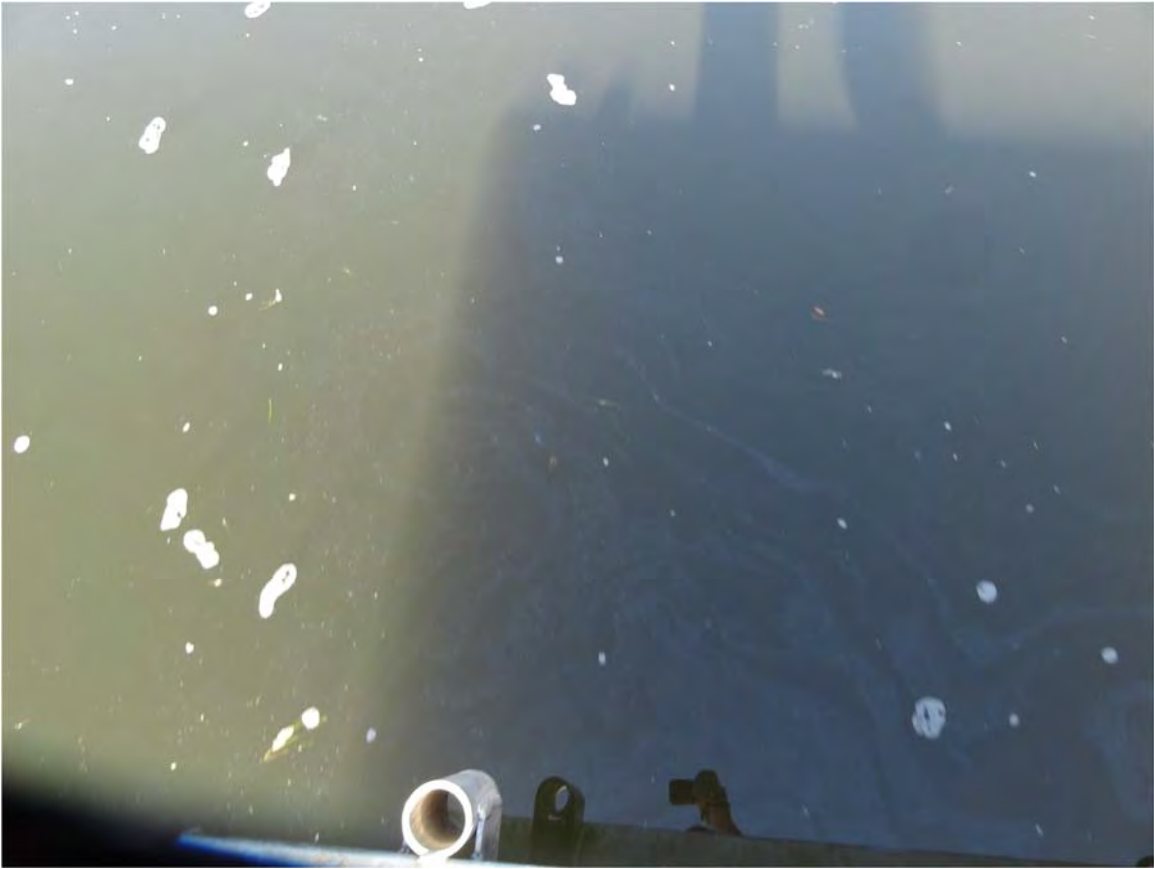
11. MP5.15 RDB sheen observed.

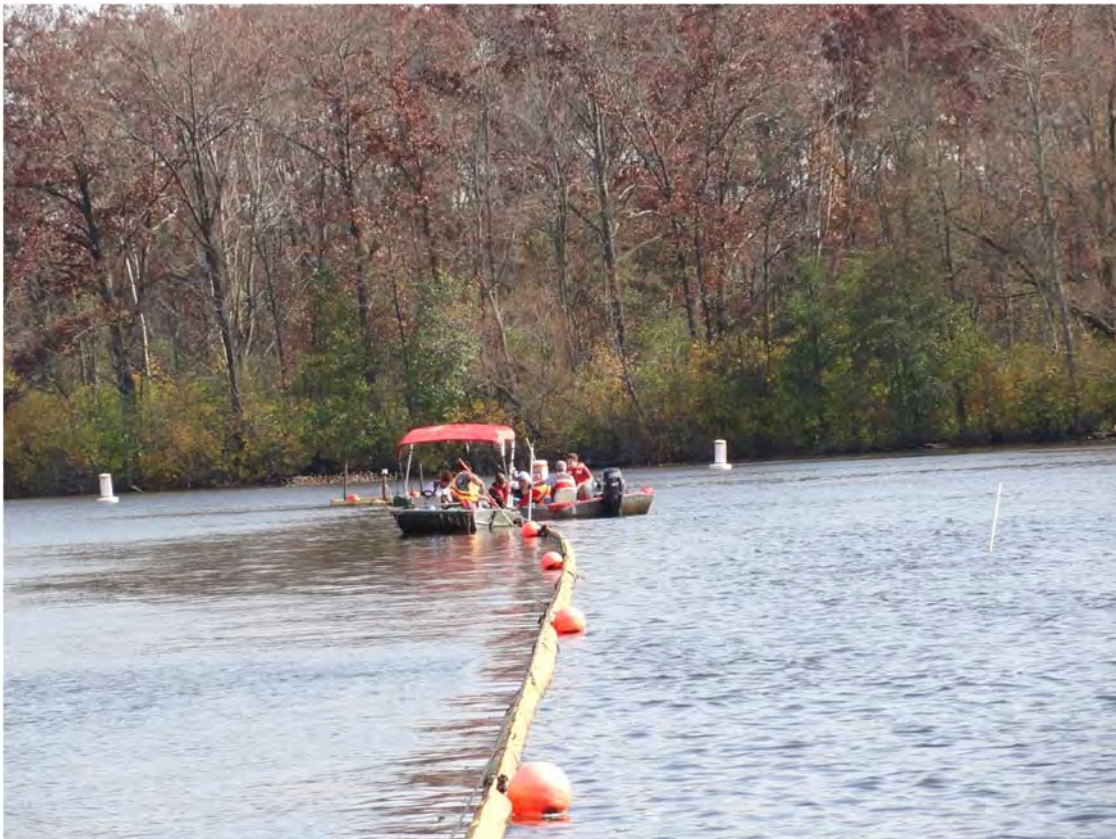
12. Morrow Lake Delta Gate E observed crews inspecting containment curtain.

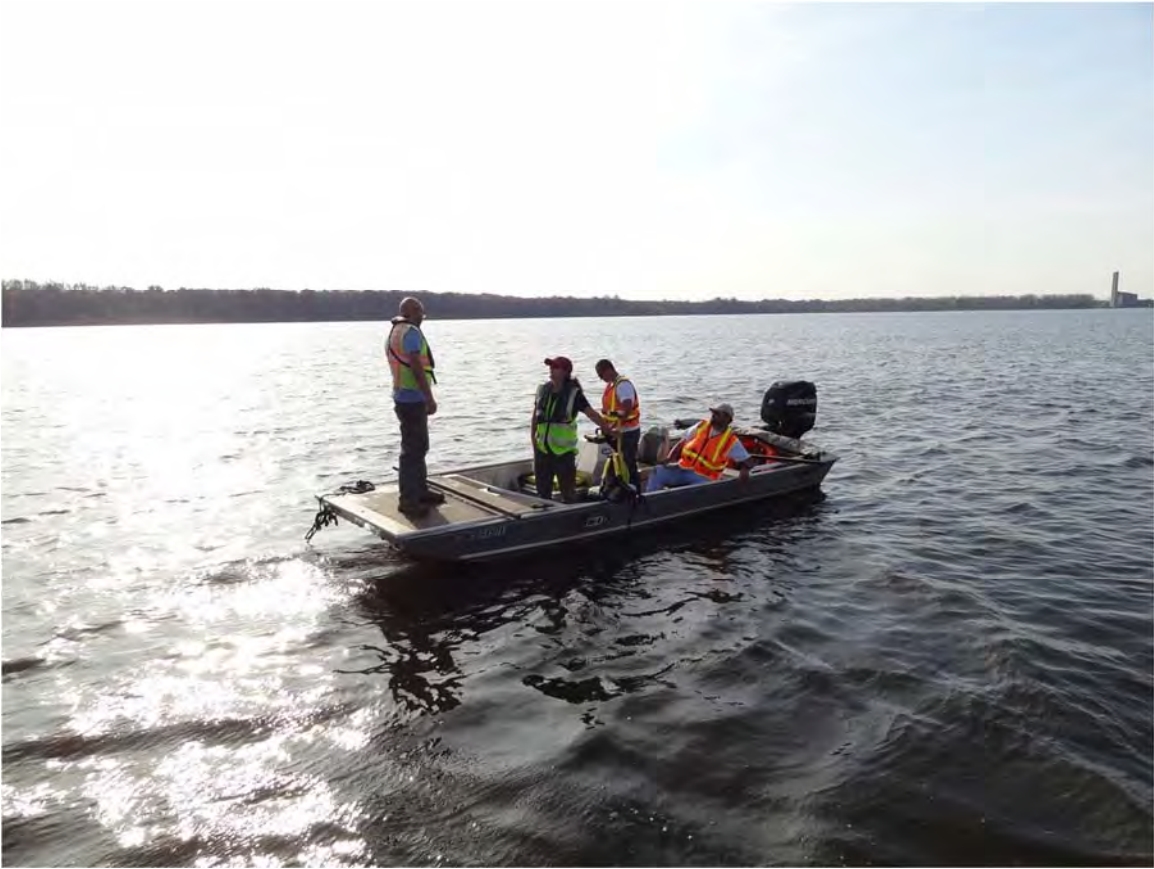
13. Morrow Lake observed a poling crew.

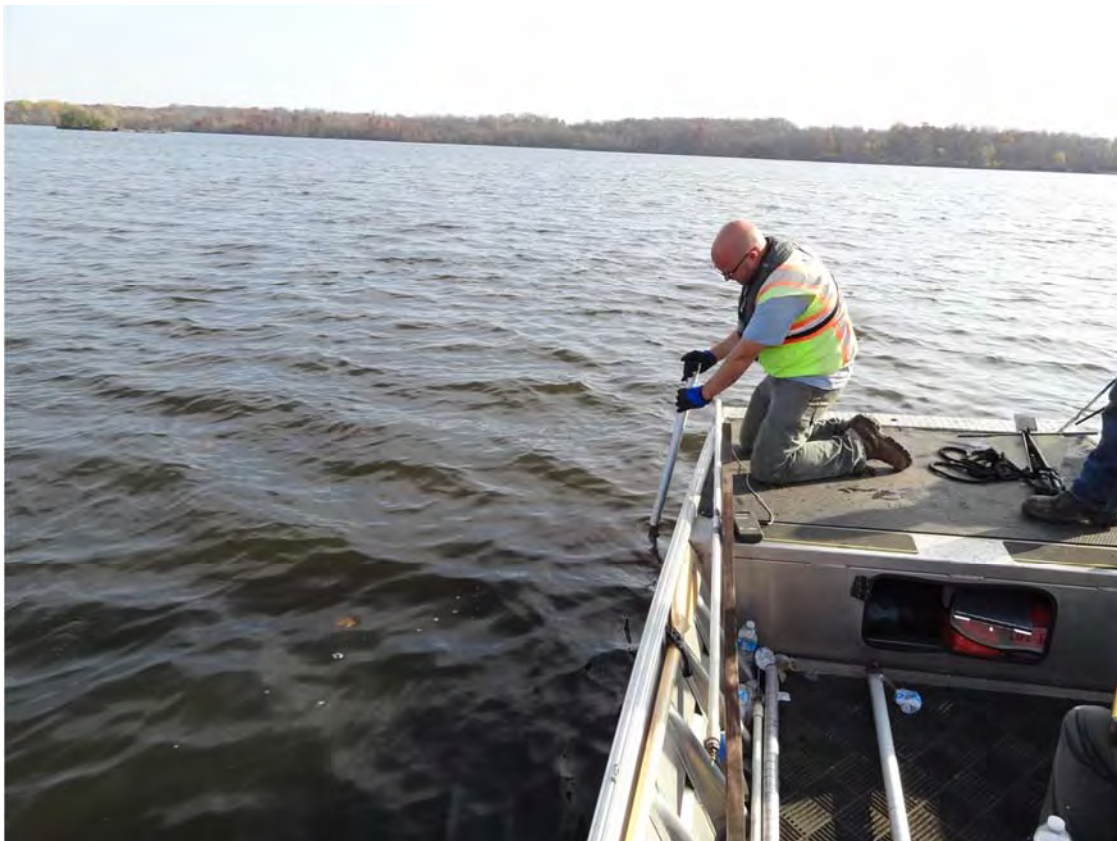
14. Morrow Lake observed a poling crew.

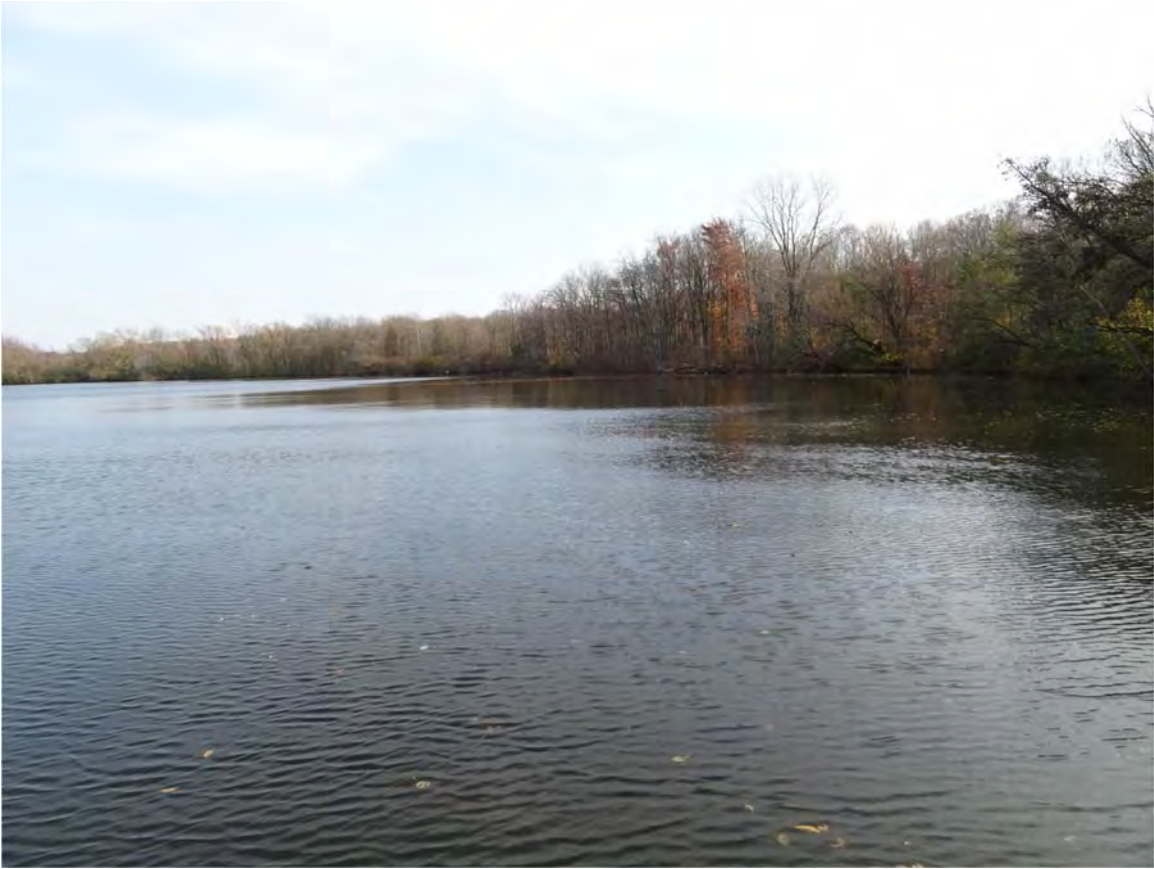
15. Morrow Lake south cove sheen observed.

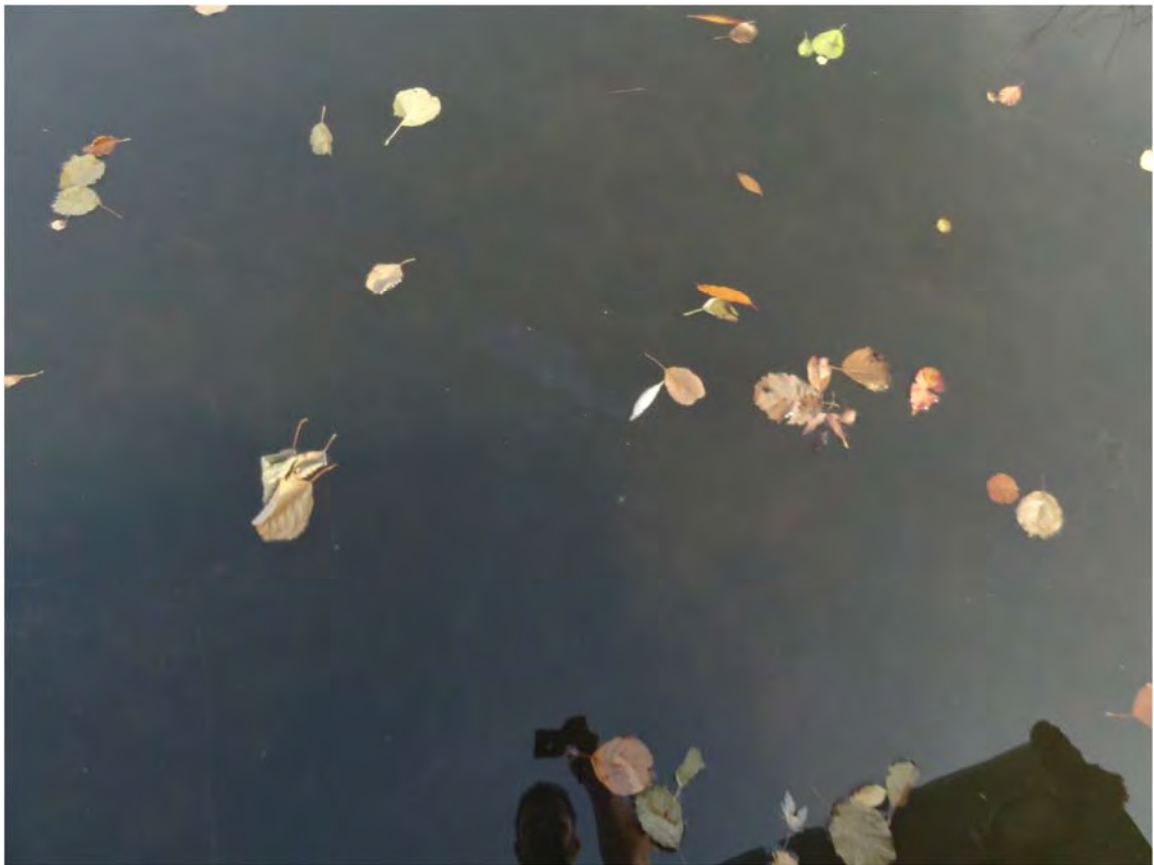
16. Morrow Lake south cove sheen observed.

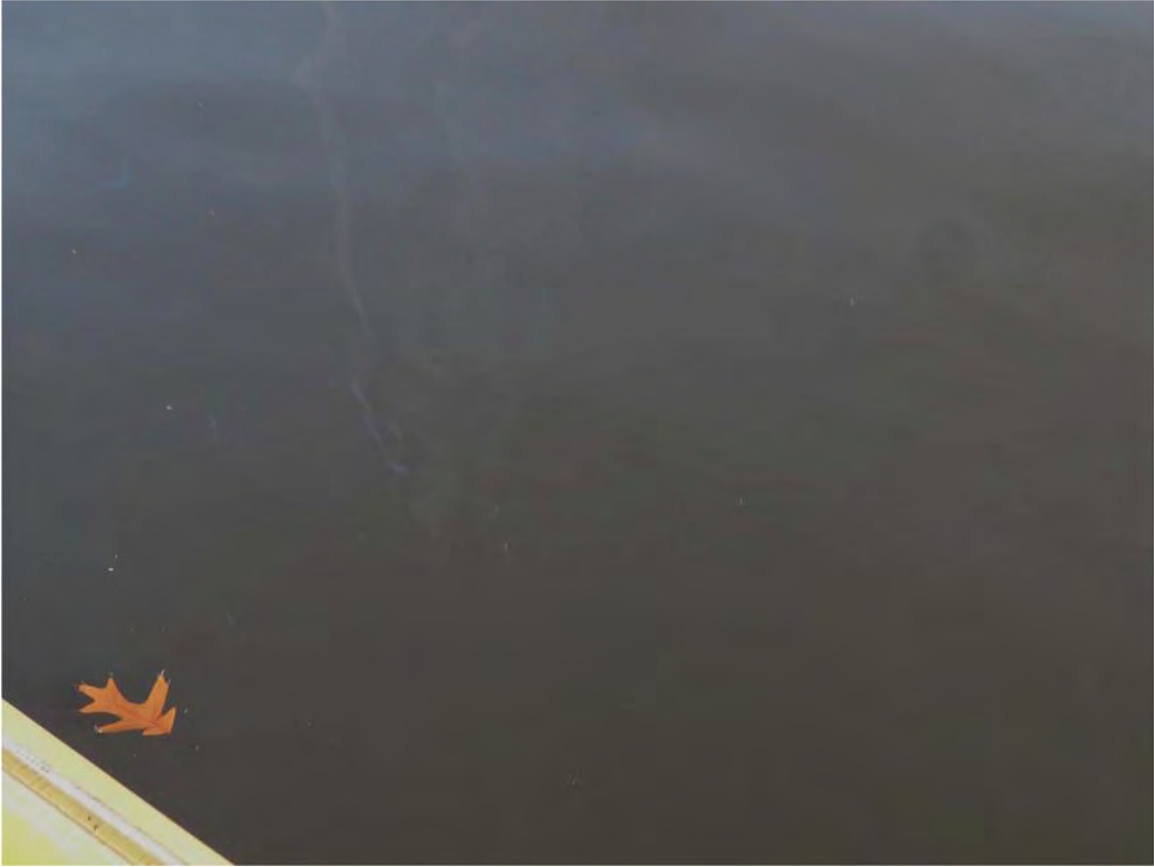
**17. Morrow Lake Delta Gate F sheen observed along the boom.**

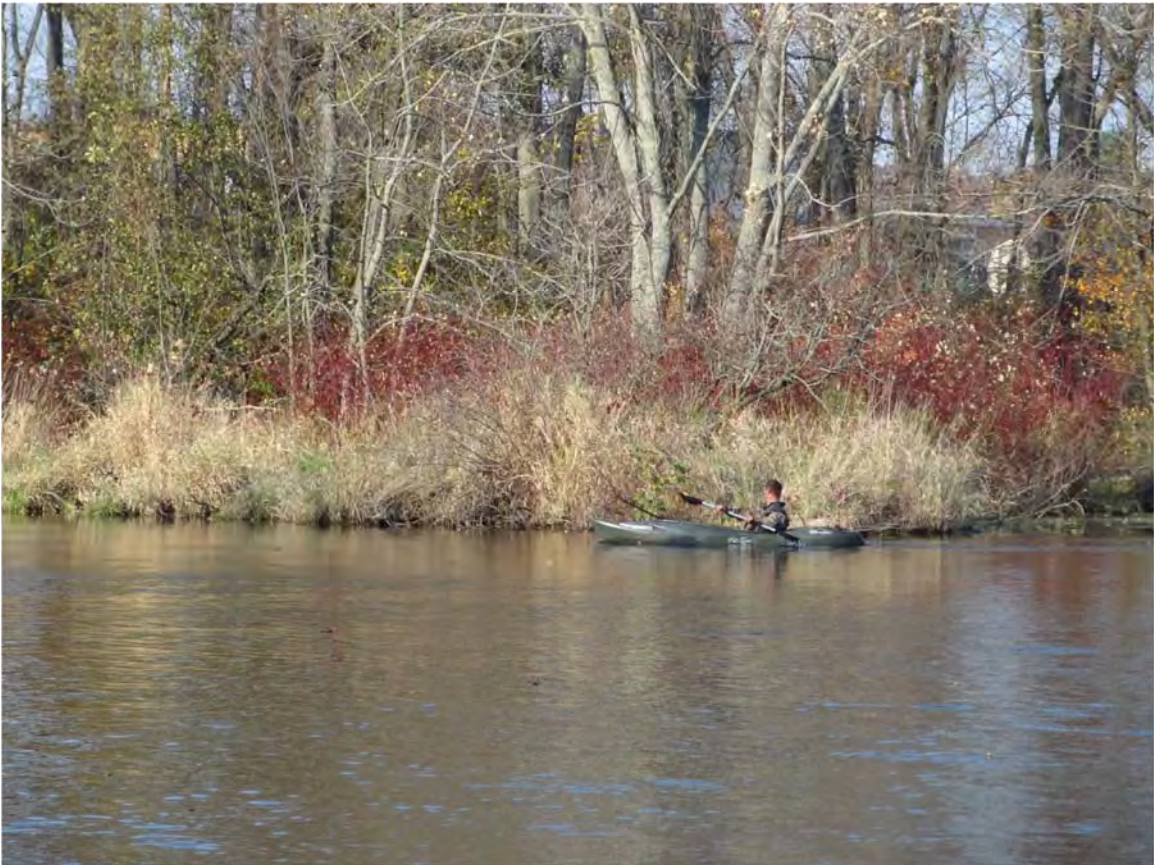
**18. MP36.5 observed a hunter exiting the wetland area.**
